Navajo Abandoned Uranium Mine

Site Screen Report

Mine Name: Black Mountain Vase
Mine ID: 405

August 2011

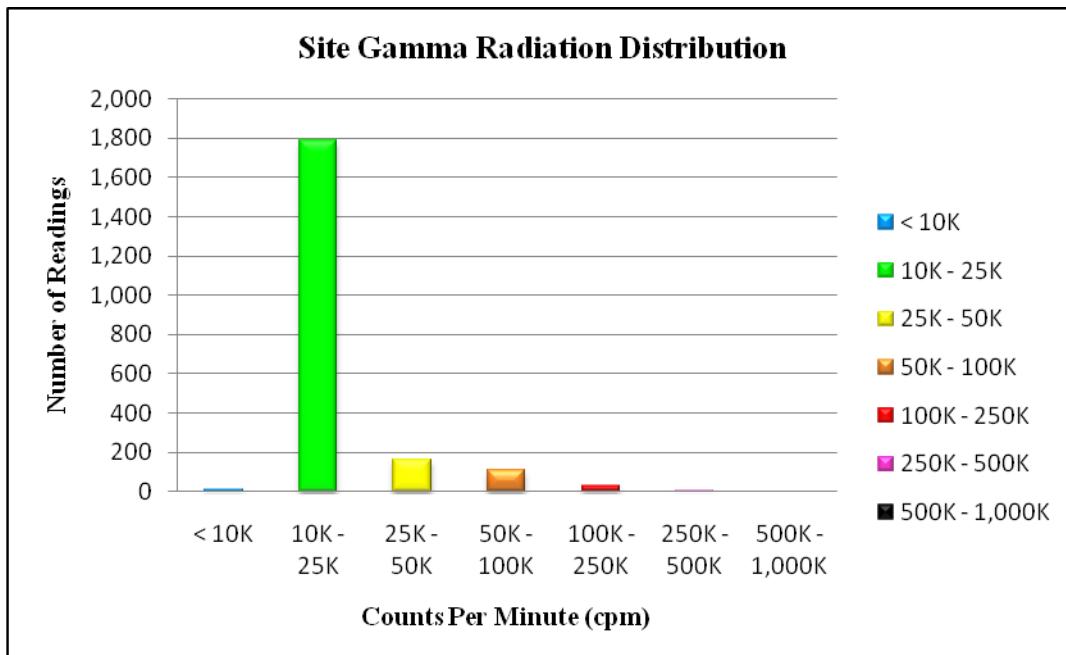
Highest gamma radiation measurement: 290,930 counts per minute (cpm)

Background Average: 16,460 cpm **Two Times Background:** 32,920 cpm

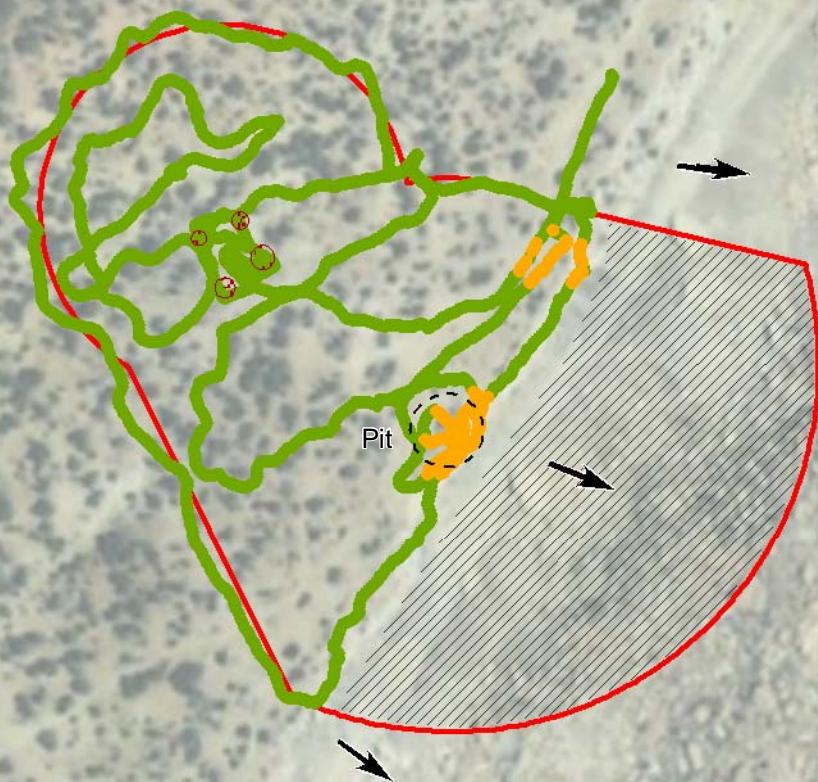
Figure 1 - Gamma Radiation Measurements, Above Two Times Background
Black Mountain Vase (405)
Tselani Chapter, Navajo Nation

A total of 2,102 gamma radiation measurements were collected from the mine site, ranging from 9,294 cpm to 290,930 cpm. Measurements collected in the vicinity of the cliff area were found at a maximum level of approximately 290,000 cpm. The measurements are represented in Figures 1 and 2.
